# **EXHIBIT No. 5**

ARCCA, INCORPORATED  
146 N CANAL STREET, SUITE 300  
SEATTLE, WA 98103  
PHONE 877-942-7222 FAX 206-547-0759  
www.arcca.com

Re: *Quinn, Dennis v. Marie Ronkar*  
ARCCA Case No.: 3691-015

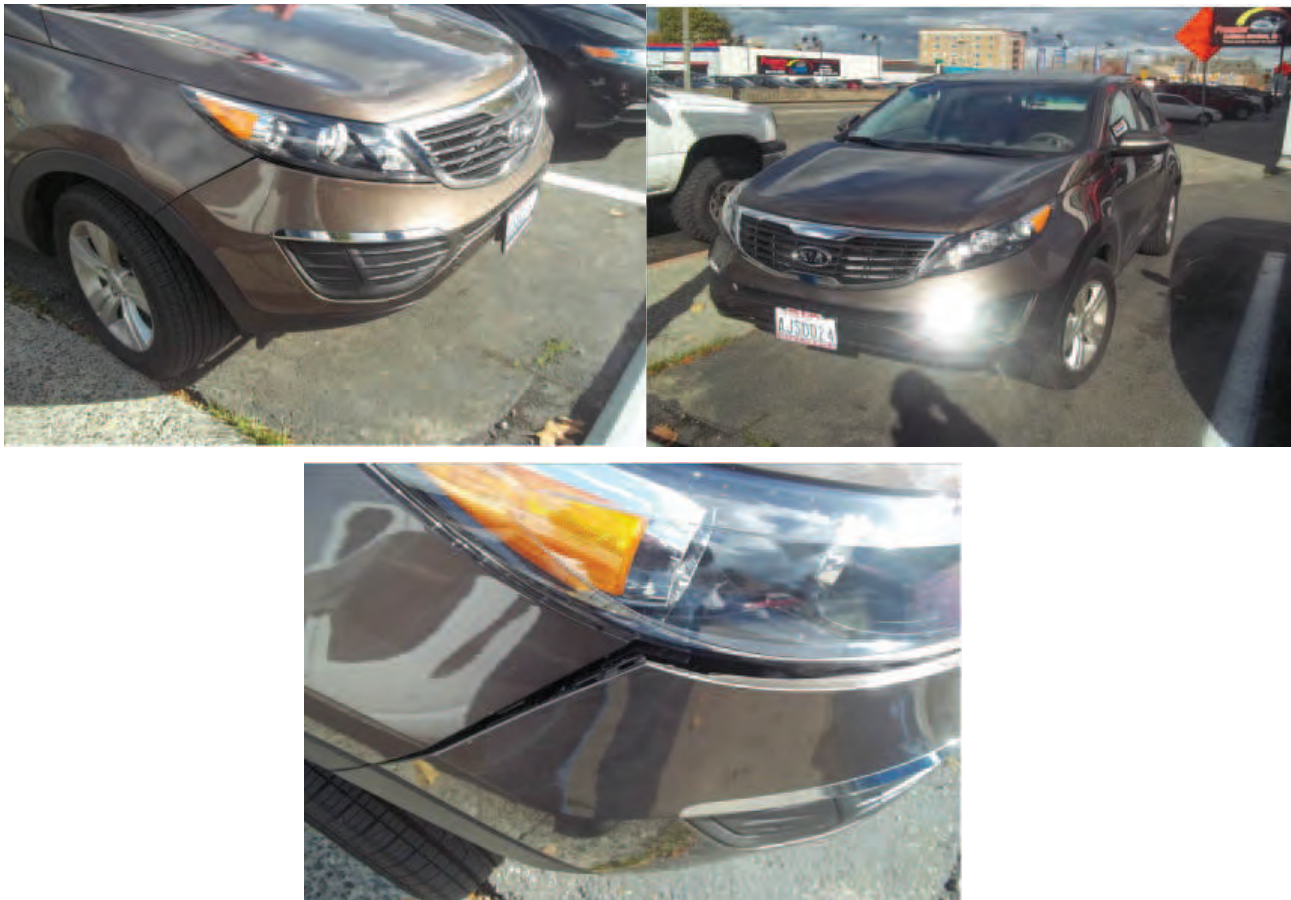
**Figure 2: Reproductions of photographs of the incident 2012 Kia Sportage**

The repair documents for the incident 2012 Kia Sportage indicated there was damage to the valence panel, lower grille, impact bar, license bracket, radiator sight shield, air conditioning condenser, and front bumper cover. The photographs depicted the front bumper cover slightly displaced near the right fender junction, just below the right headlight (Figure 2). The front license plate had a minor bend rearwards under the front bumper. There was no significant residual crush to the front bumper cover, and it remained in alignment with the grille.

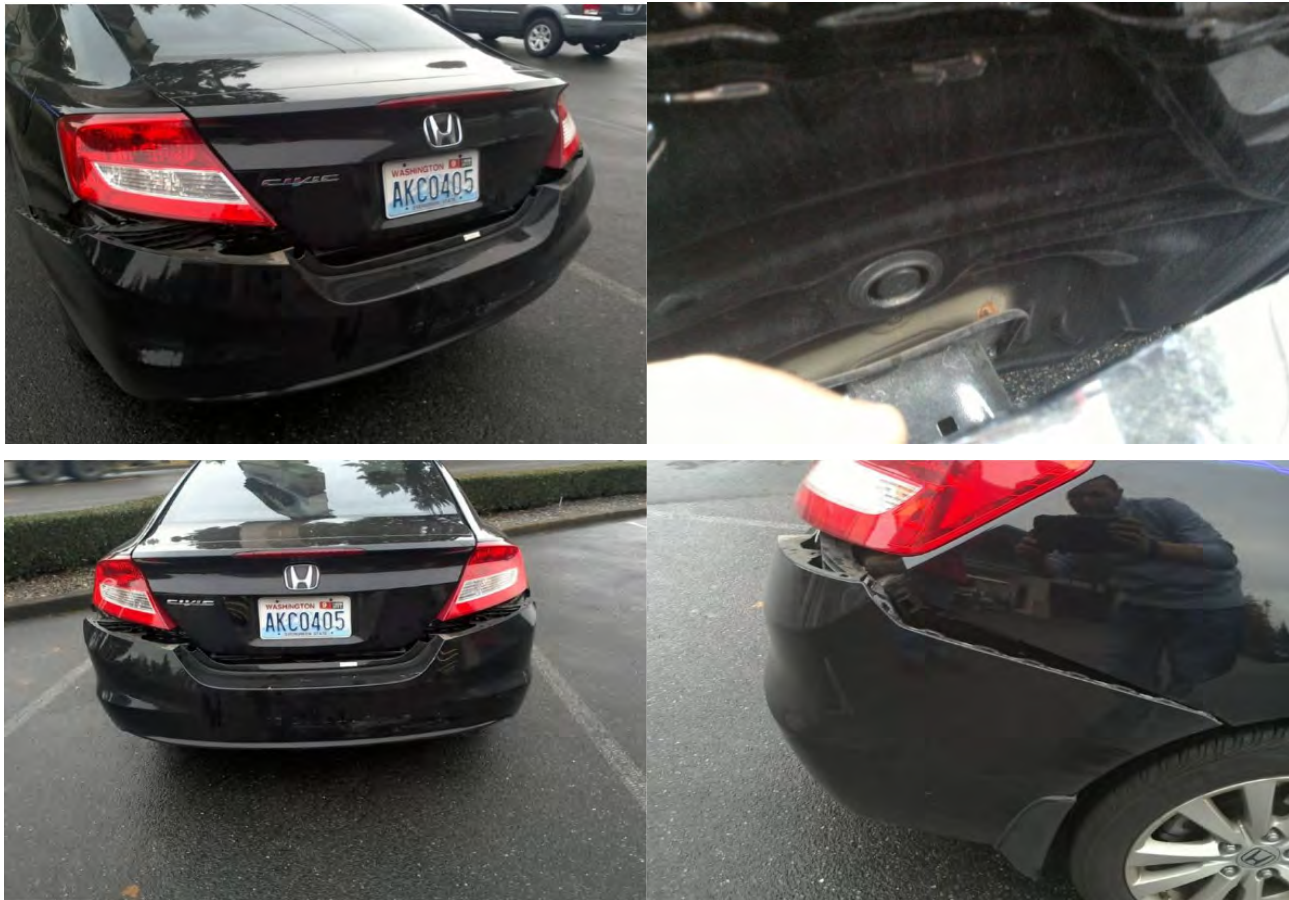
**Figure 1: Reproductions of photographs of the subject 2012 Honda Civic**

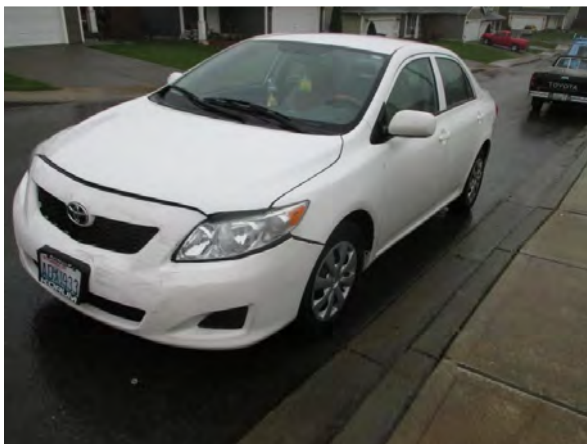
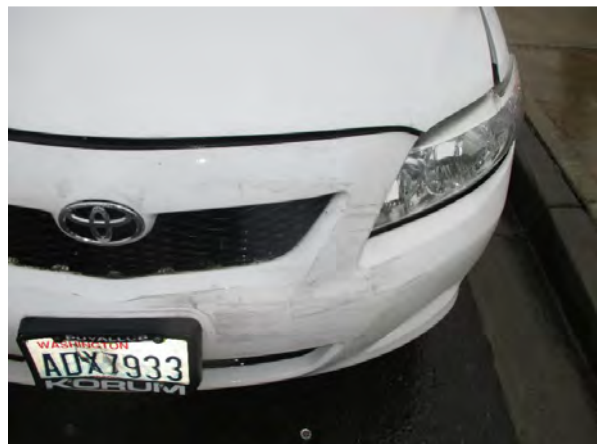
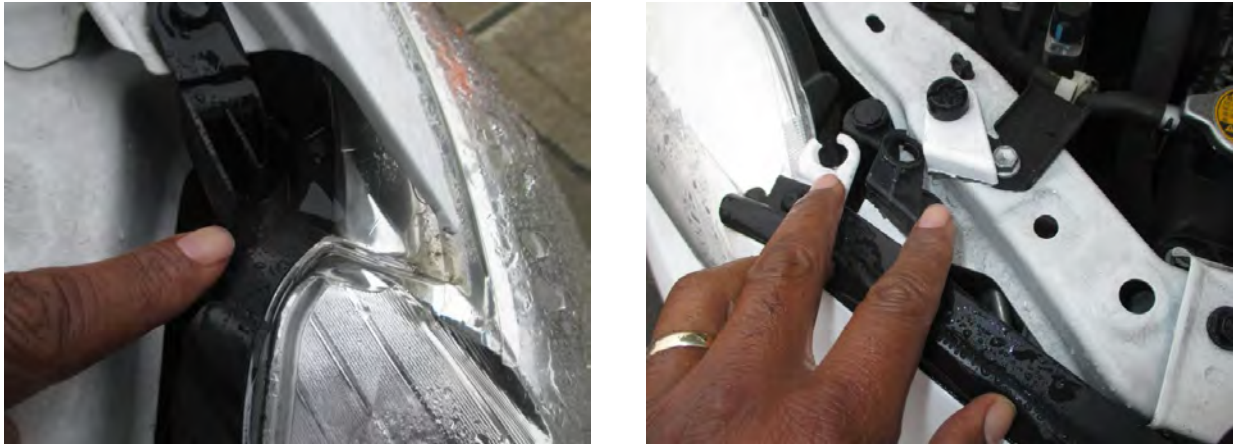
The repair documents for the incident 2010 Toyota Corolla indicated there was damage primarily to the left front head lamp, front bumper absorber, reinforcement, bumper cover, license bracket, left fender rail end, hood support rod holder, left fender, grille, radiator support, and left upper support. The photographs depicted black scuffs and paint transfer to the left and center of the front bumper (Figure 2). The grille and front bumper cover were displaced relative to the left fender, hood, and left headlamp. The left headlamp was also displaced and partially cracked. The front bumper was bent just right of center. A clip connecting to the radiator support bracket was also fractured.

**Figure 2: Reproductions of photographs of the incident 2010 Toyota Corolla**

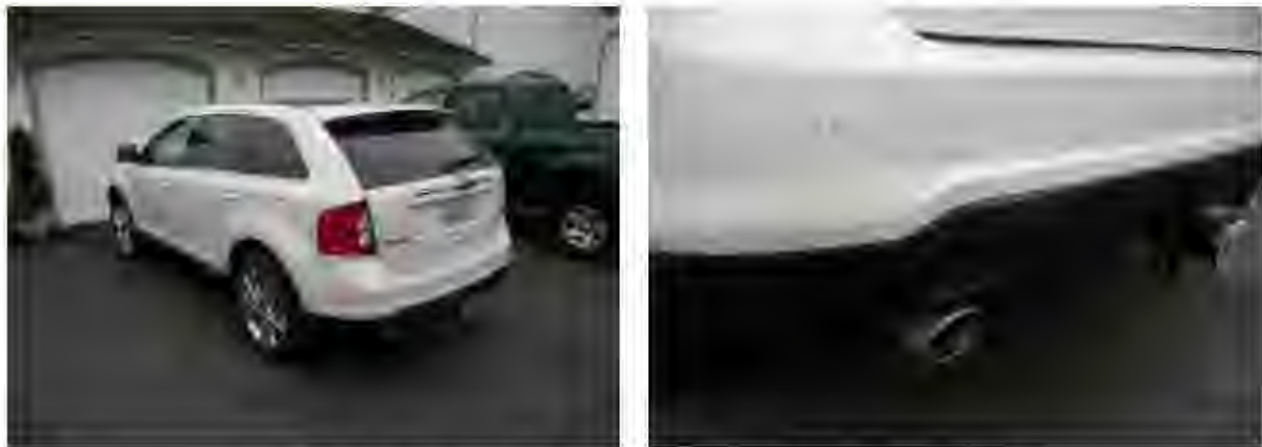
**Figure 1: Reproductions of photographs of the subject 2011 Ford Edge**

Energy-based crush analyses have been shown to represent valid and accurate methods for determining the severity of automobile collisions.<sup>13,14,15,16,17</sup> Analyses of the photographs and geometric measurements of the subject 2011 Ford Edge revealed the damage due to the subject incident. An energy crush analysis<sup>18</sup> indicates that a single 10 mile per hour flat barrier impact to the rear of an exemplar Ford Edge would result in significant and visibly noticeable crush across the entirety of the subject Edge's rear structure, with a residual crush of 4.0 inches. Therefore, the energy crush analysis shows significantly greater deformation would occur in a 10 mile per hour Delta-V (the Delta-V is the change in velocity of the vehicle from its pre-impact, initial velocity, to its post-impact velocity) impact than that of the subject incident.<sup>19</sup> The lack of significant structural crush to the entire rear of the subject Ford Edge indicates a collision resulting in a Delta-V significantly below 10 miles per hour.

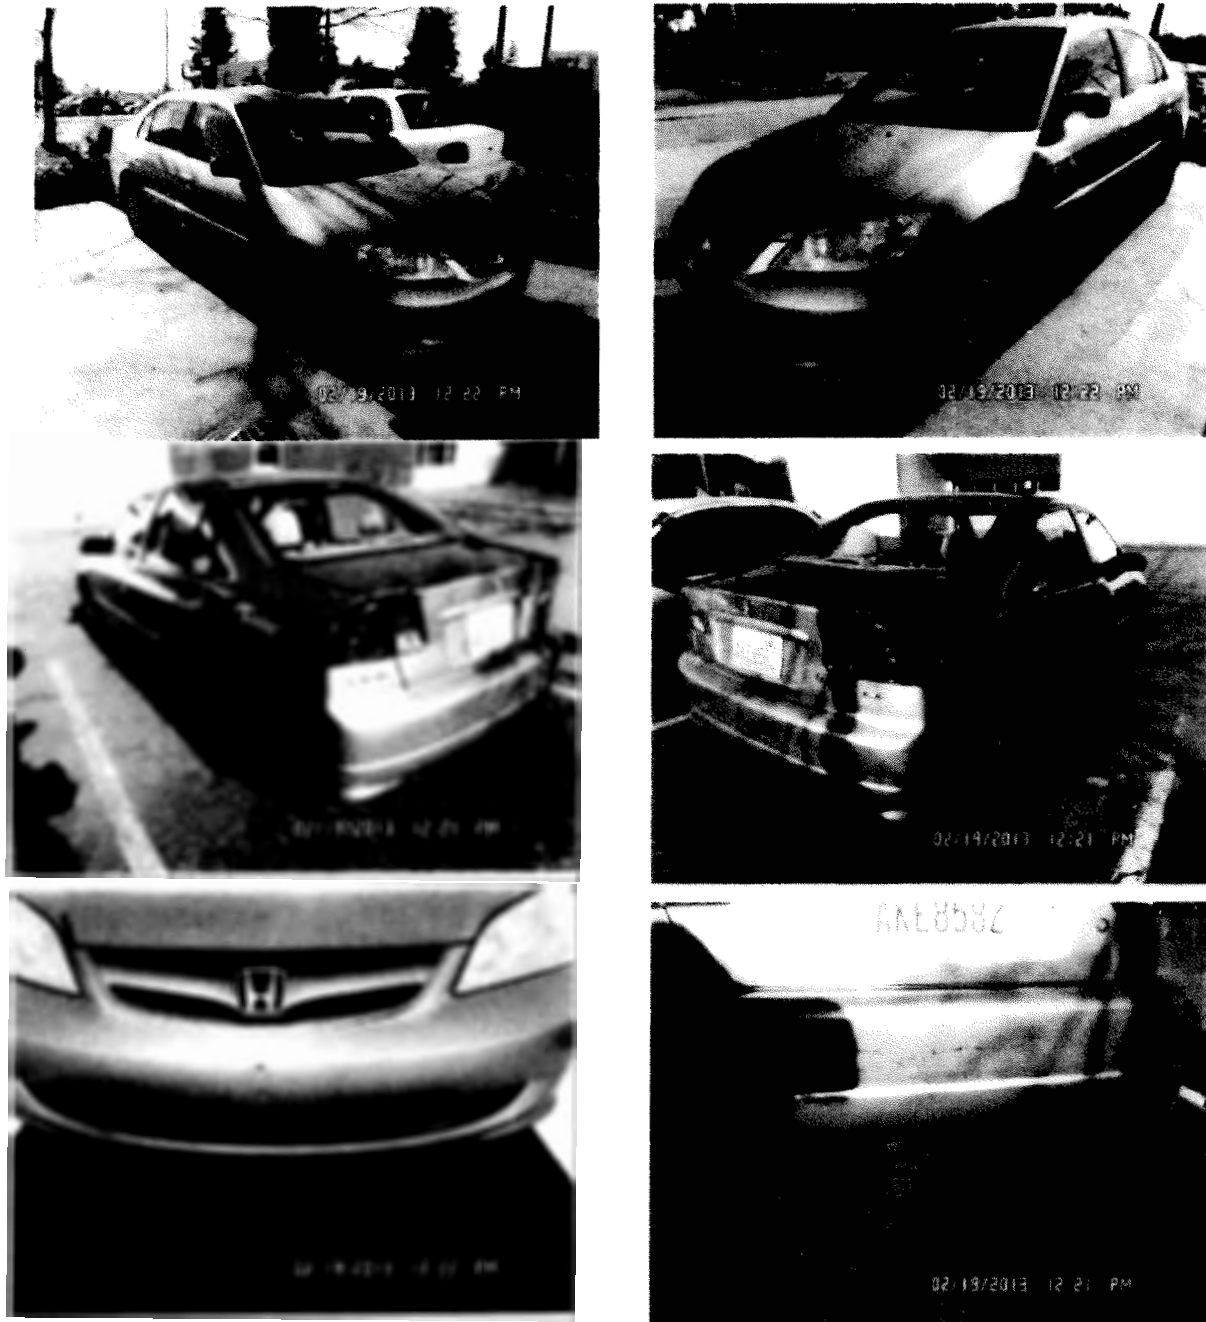
**Figure 1: Reproductions of photographs of the incident 2005 Honda Civic**

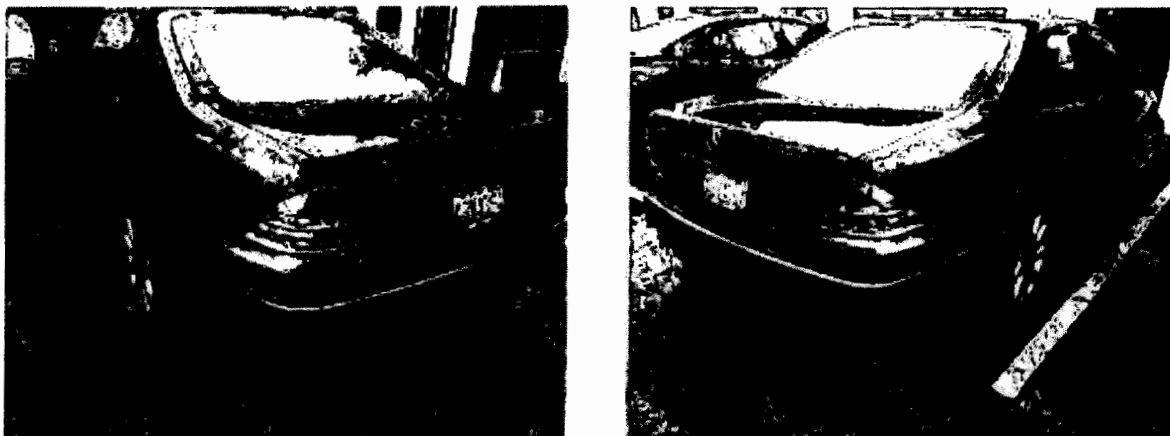
The repair estimate for the subject 2001 Mercedes-Benz S500 reported damage to the rear bumper cover and center bumper impact strip. The photographs were of low quality, but did not depict significant crush to the rear of the subject vehicle (Figure 4).

**Figure 4: Reproductions of photographs of the subject 2001 Mercedes-Benz S500**

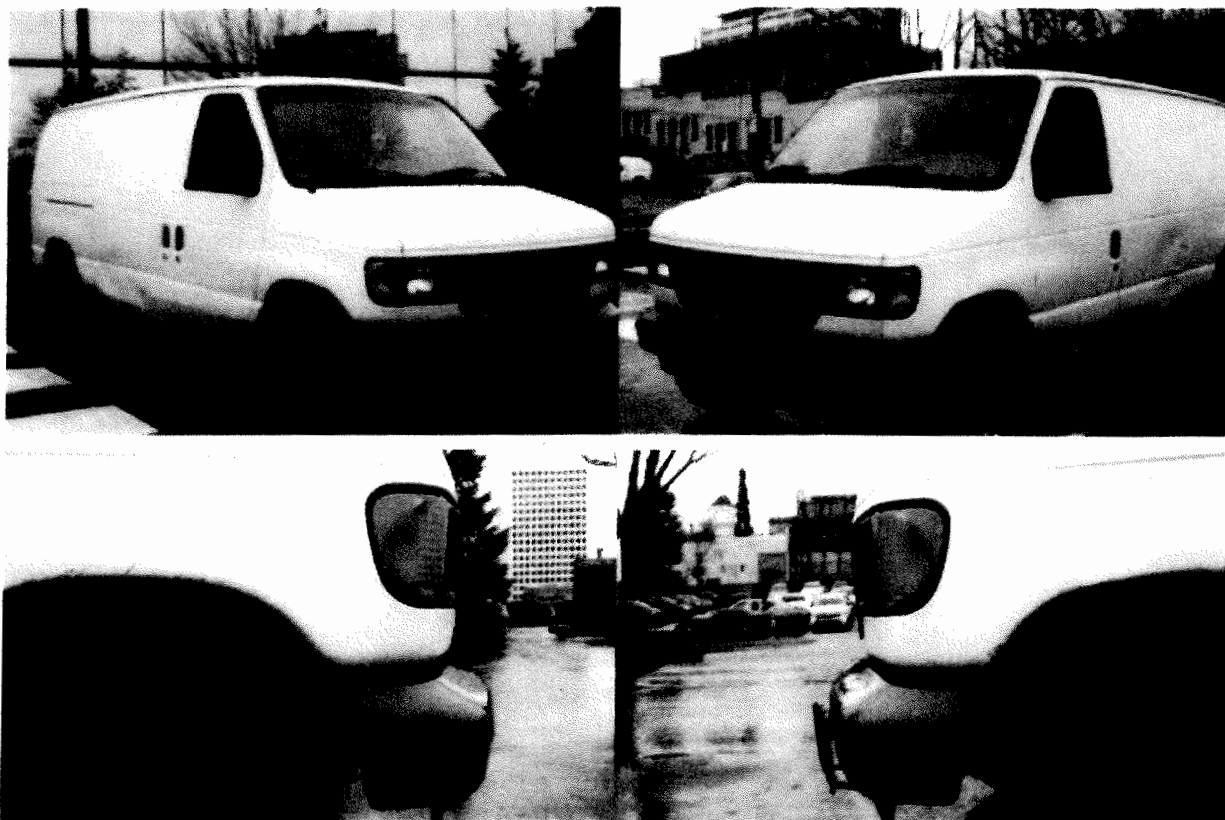
The photographs of the incident 2006 Ford E250 depicted a dent to the left side of the front bumper, and paint chips to the right side of the bumper (Figure 5). The front bumper remained in alignment with the grille and fenders. There was also damage to the left and right side panels which was unrelated to the subject incident.

**Figure 5: Reproductions of photographs of the incident 2006 Ford E250**

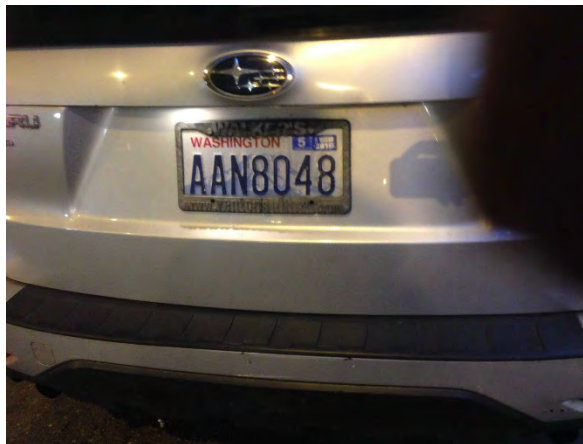
**Figure 2: Reproduction of photograph of the incident 2010 Subaru Forester**

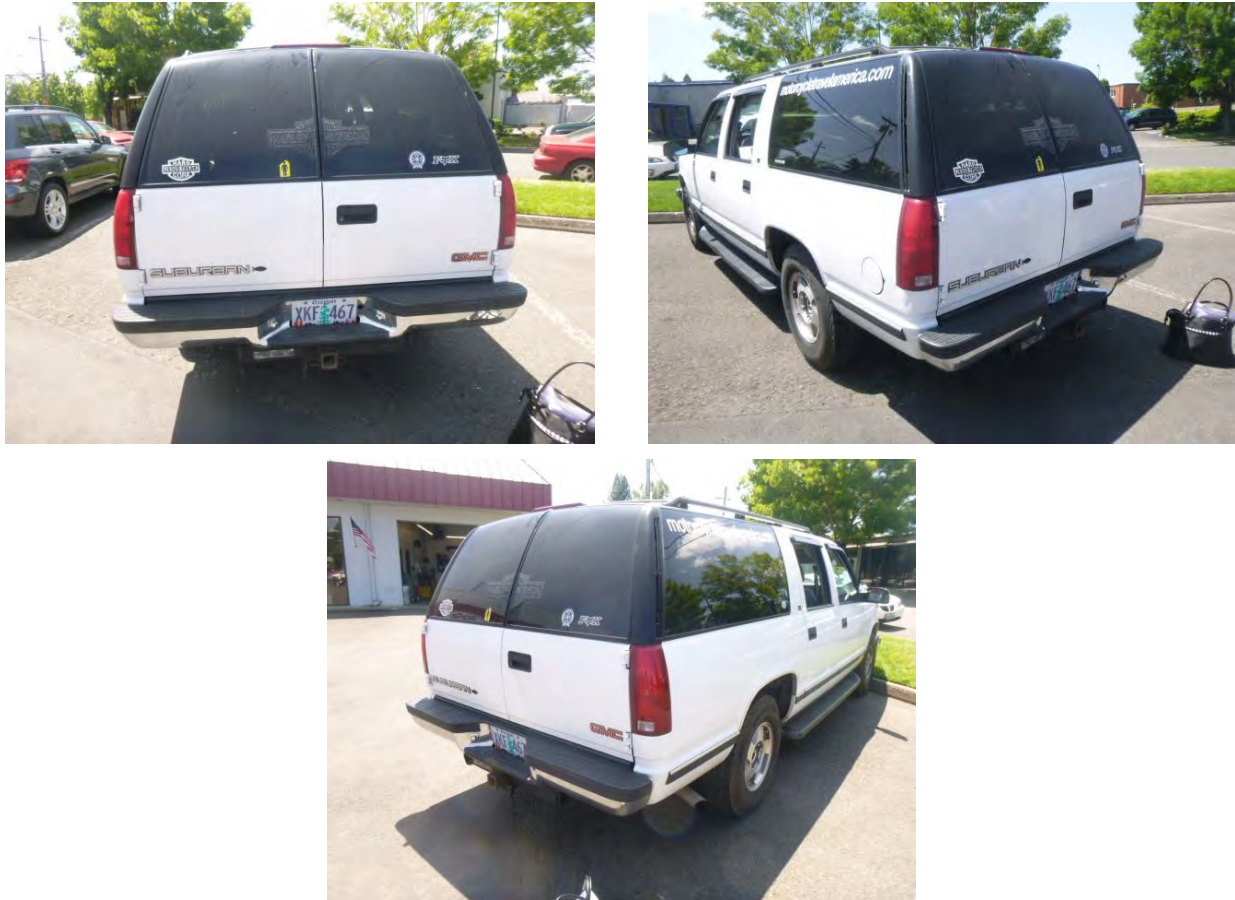
**Figure 1: Reproductions of photographs of the subject 1999 GMC Suburban**

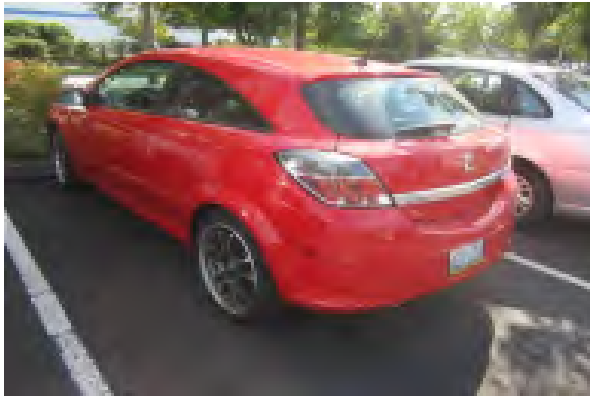
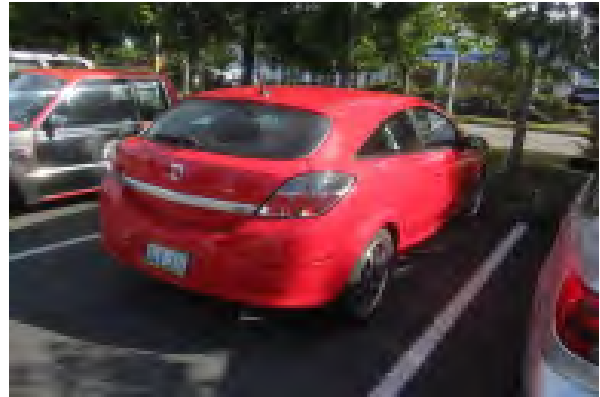
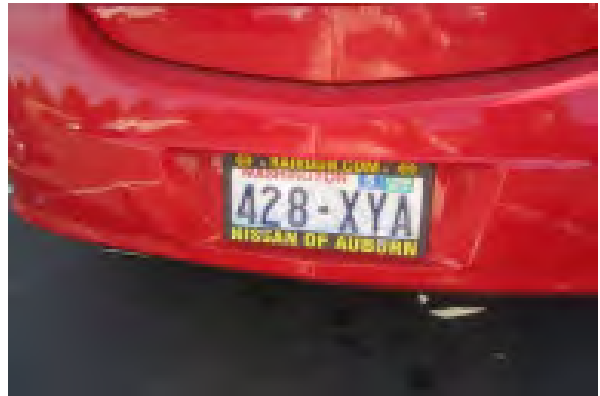
**Figure 1: Photographic reproductions of the subject 2008 Saturn Astra**

The Insurance Institute for Highway Safety (IIHS) performs low-speed tests on vehicles to assess the performance of the vehicles' bumpers and the damage incurred. The damage to the subject Saturn Astra, defined by the photographic reproductions, and confirmed by the repair estimate, was used to perform a damage threshold speed change analysis.<sup>8</sup> The IIHS tested a 2008 Saturn Astra in a 6.2 mile-per-hour front impact into a rigid barrier.<sup>9</sup> The test Saturn sustained damage to the inner cover support, lid deck molding, rear body panel, rear bumper, rear bumper cover, absorber, left/right rear bumper mounting bracket, and required a rear body panel pull (Figure 3). The primary damage to the subject incident Saturn Astra was to the rear bumper cover, impact bar, and left outer support. Thus, because the test Saturn in the IIHS rear impact test sustained greater damage, the severity and energy transfer of the IIHS impact is greater compared to the severity of the subject incident and places the Saturn Astra speed below the test speed of 6.2 miles-per-hour. Accounting for restitution, the subject Saturn experienced a Delta-V below 8.0 miles-per-hour.<sup>10,11</sup>

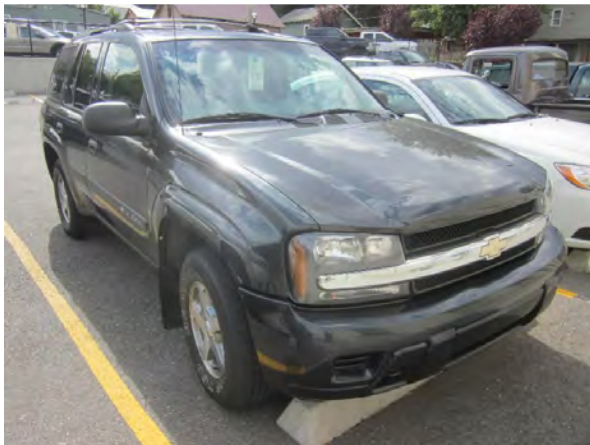
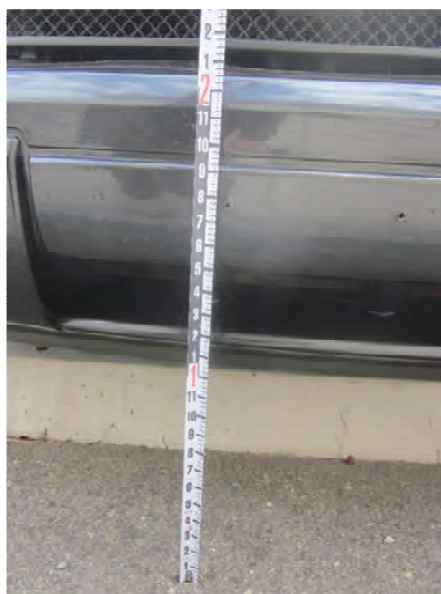
**Figure 2: Photographic reproductions of the incident 2004 Chevrolet Trailblazer**

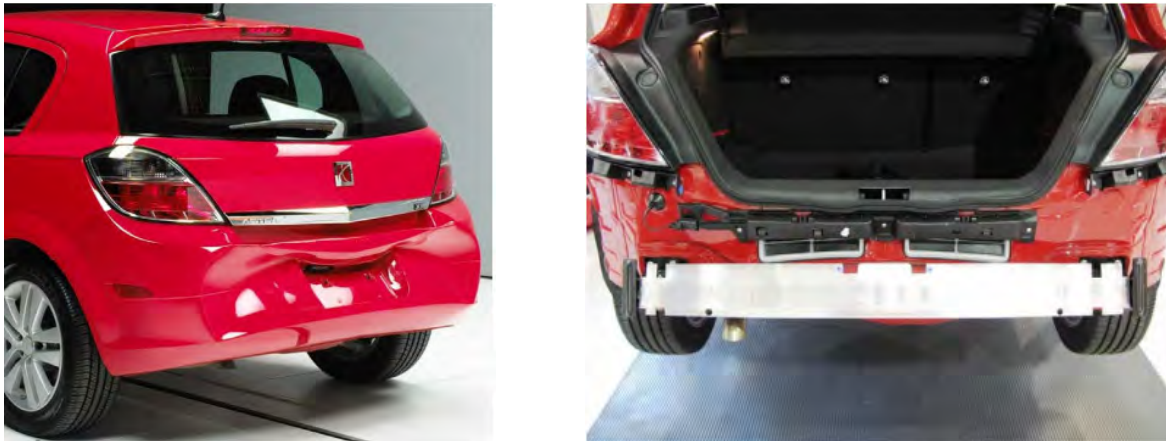
**Figure 3. Photographic reproductions of the 2008 Saturn Astra in the IIHS rear impact test**

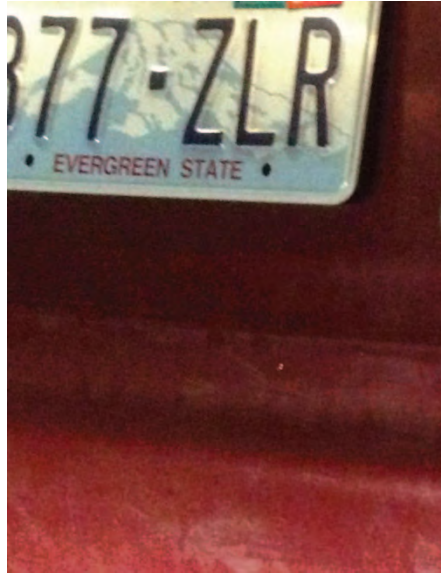
**Figure 1: Reproduction of photograph of the subject 2002 Dodge Grand Caravan**

The Insurance Institute for Highway Safety (IIHS) performs low-speed tests on vehicles to assess the performance of the vehicles' bumpers and the damage incurred. The damage to the subject Grand Caravan, defined by the photographic reproductions, and confirmed by the repair estimate, was used to perform a damage threshold speed change analysis.<sup>8</sup> The IIHS tested a 2001 Dodge Grand Caravan, the same production year and series as a 2002 Dodge Grand Caravan, in a 5 mile-per-hour rear impact into a flat barrier.<sup>9</sup> The test Dodge sustained damage to the rear bumper reinforcement, bumper mounting brackets, rear body panel, and tailgate. The primary damage to the subject Dodge was to the rear bumper cover. Thus, because the test Grand Caravan in the IIHS rear impact test sustained greater damage, the severity and energy transfer of the IIHS impact is greater compared to the severity of the subject incident. Accounting for restitution, the subject Dodge Grand Caravan experienced a

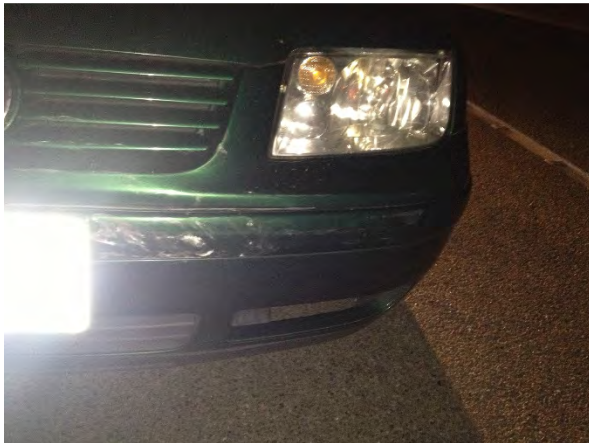
The photographs of the 2001 Volkswagen Jetta depicted scrapes along the left side of the front bumper cover, but no significant crush (Figure 2).

**Figure 2: Reproductions of photographs of the incident 2001 Volkswagen Jetta**

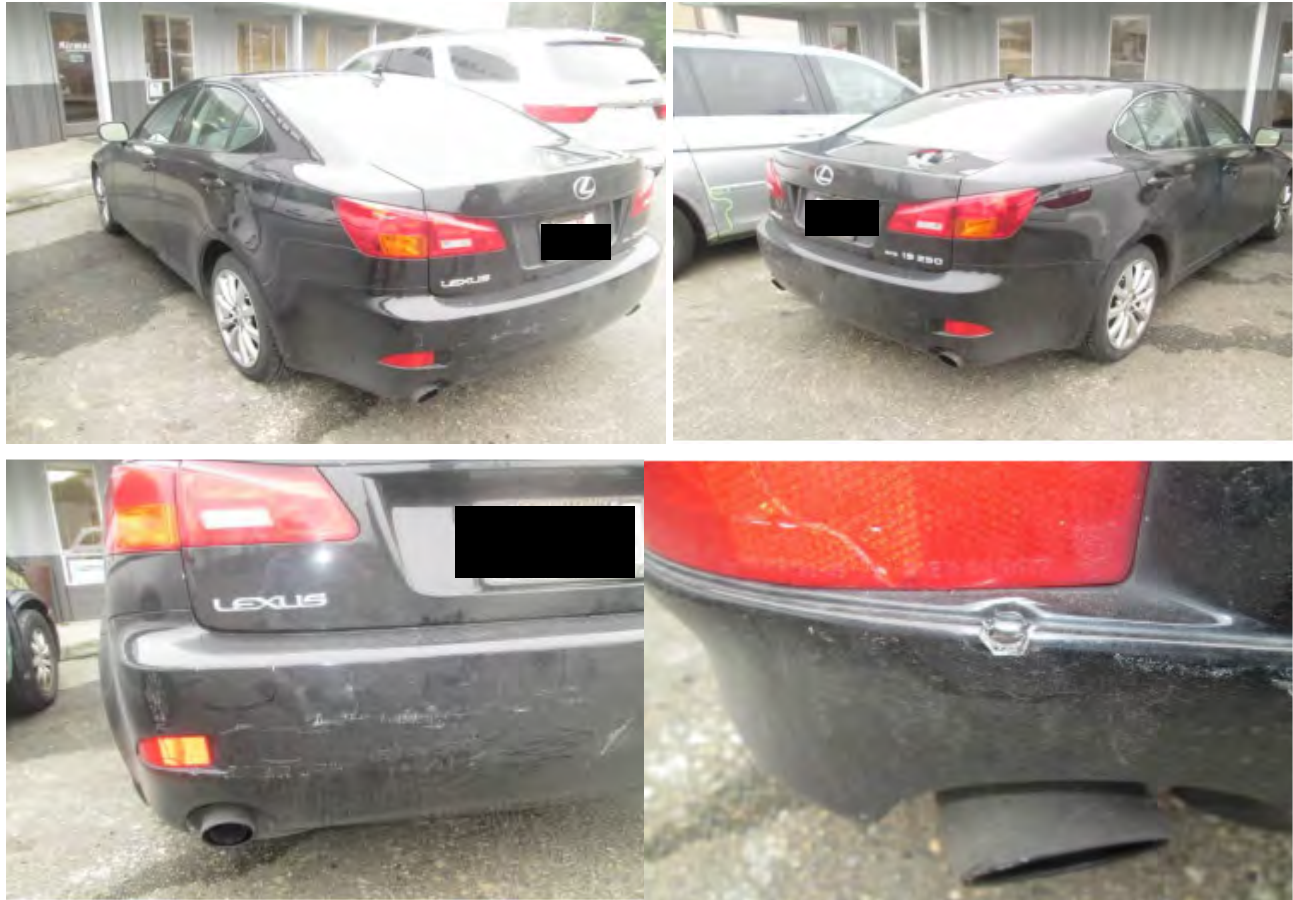
**Figure 1: Photographic reproductions of the subject 2007 Lexus IS 250**

The Insurance Institute for Highway Safety (IIHS) performs low-speed tests on vehicles to assess the performance of the vehicles' bumpers and the damage incurred from the test. The damage to the Lexus IS 250, defined by the photographic reproductions and confirmed by the repair estimate, was used to perform a damage threshold speed change analysis.<sup>8</sup> The IIHS tested a 2007 Lexus IS Series in a 6.2 mile-per-hour (mph) rear impact into a full-width barrier.<sup>9</sup> The tested Lexus sustained damage to the pull clamps, L/R rail, left quarter panel, rear body panel, rear bumper, rear bumper outer extensions, rear bumper cover, rear bumper reinforcements, rear bumper absorber, and required a frame measurement. The primary damage to the subject Lexus was to the rear bumper cover, left reflector, energy absorber, trunk emblem, rear bumper, rear body panel, trunk lid, and a frame pull was performed. Thus, because the Lexus IS Series in the IIHS rear impact test sustained similar damage to the subject Lexus, the severity and energy transfer of the IIHS impact is consistent with the severity of the subject incident. Therefore, when accounting for restitution, the subject Lexus IS 250 experienced a Delta-V (the Delta-V is the change in velocity of the vehicle from its pre-impact, initial velocity, to its post-impact velocity) of approximately 8.0 mph.<sup>10</sup>

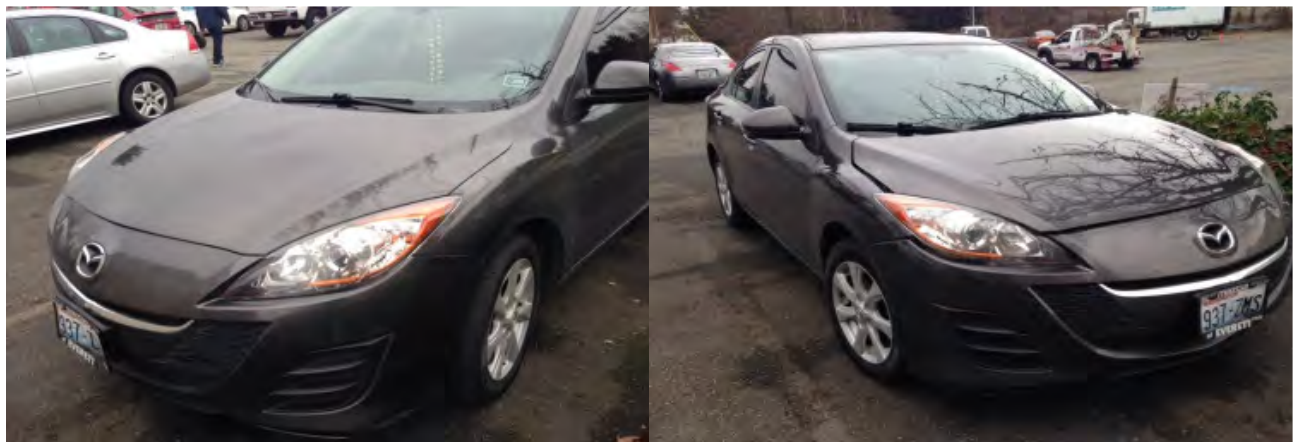
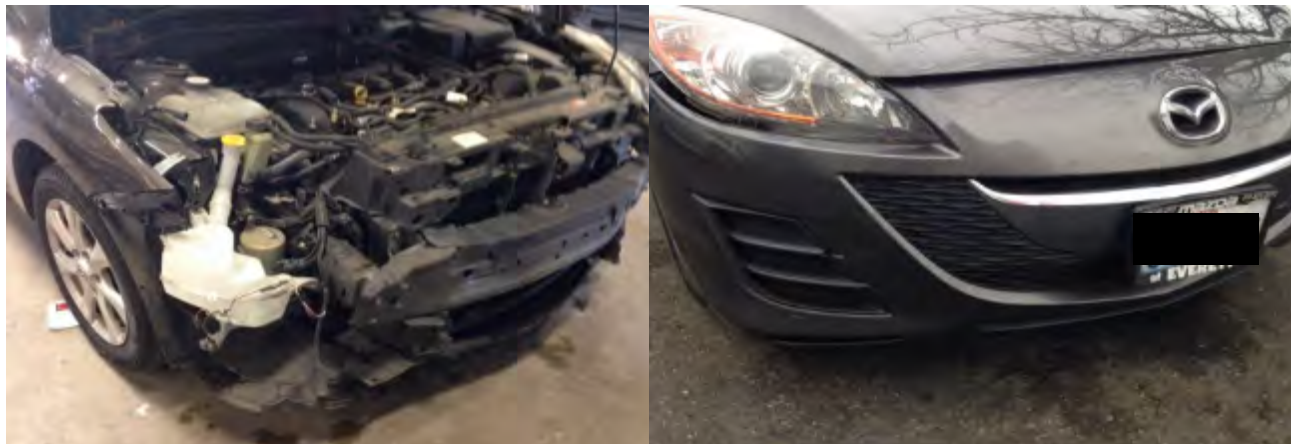
The repair estimate for the incident 2010 Mazda Mazda3 reported damage to the front bumper cover, license bracket, emblem, lower grille, absorber, absorber retainers, right lamp bezel, impact bar, center support, support plate, air deflector, radiator support, AC temp sensor, radiator, reservoir tank, headlamp assemblies, right rail extension, AC condenser assembly, hood/hinges, fenders, right apron assembly, and it was pulled for mash/sway. The photographs depicted the right side of the hood and front bumper cover displaced, and the front license plate was bent (Figure 2). The impact bar was crushed on the right side, and the radiator was displaced slightly rearward.

**Figure 2: Photographic reproductions of the incident 2010 Mazda Mazda3**

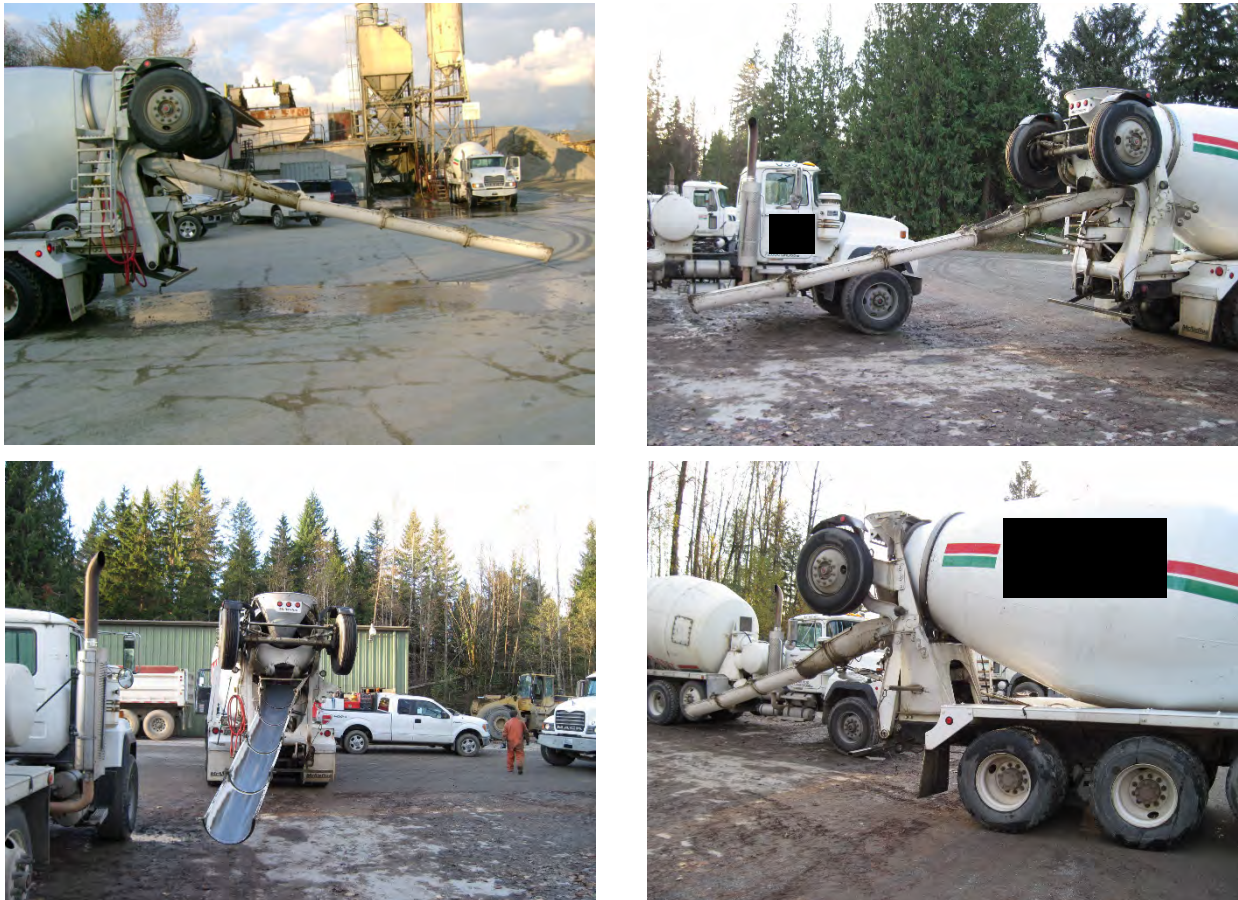
The photographs of the 1999 Mack RD6908 depicted no damage to the chute of the truck (Figure 1).

**Figure 1: Reproductions of photographs of the subject 1999 Mack RD6908**

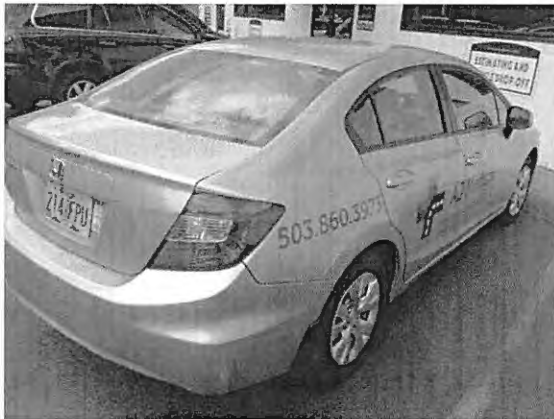
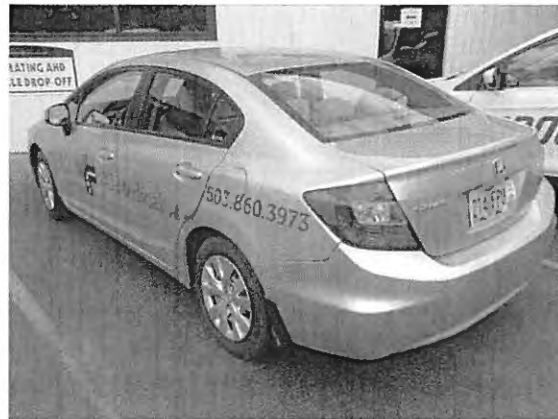
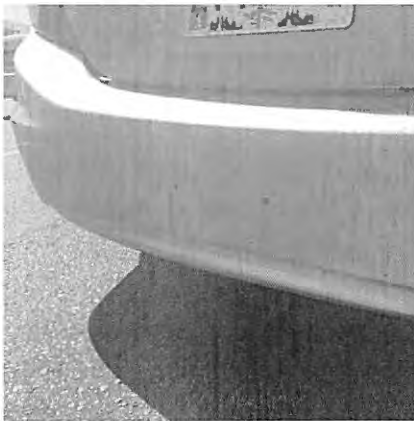
**Figure 1: Reproductions of photographs of the subject 2012 Honda Civic**

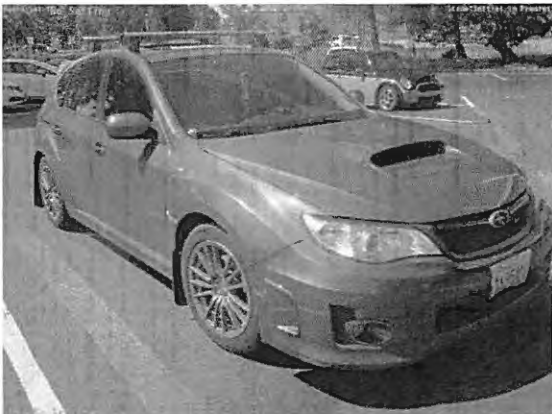
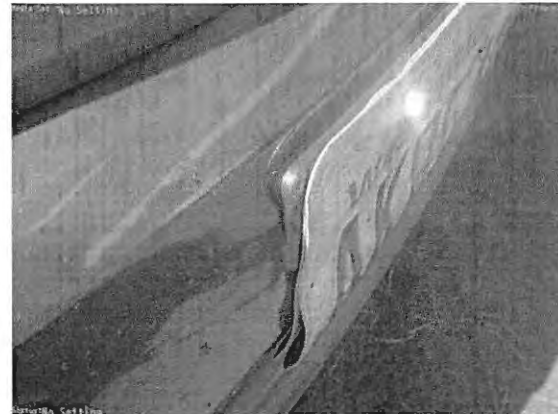
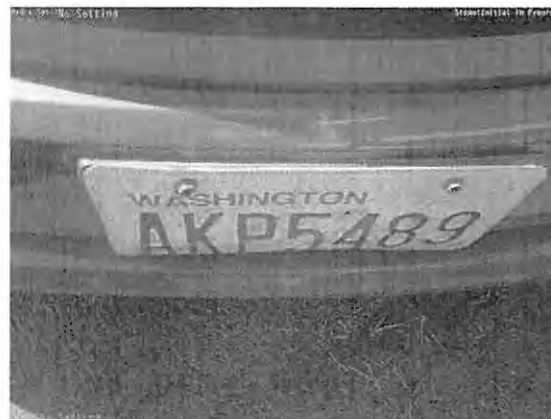
The repair documents for the incident 2013 Subaru Impreza WRX reported damage to the front bumper cover. The photographs depicted scrapes to the front bumper cover and the front license plate was bent (Figure 2). There was no significant crush to the front bumper cover, or displacement to the grille, bumper cover, headlamps, or hood.

**Figure 2: Reproductions of photographs of the incident 2013 Subaru Impreza WRX**

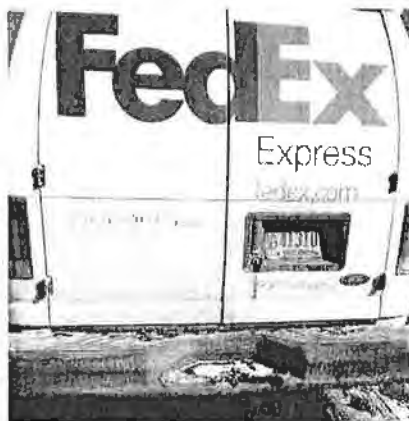
**Figure 1: Photographic reproduction of the subject 2007 Ford Econoline E250**

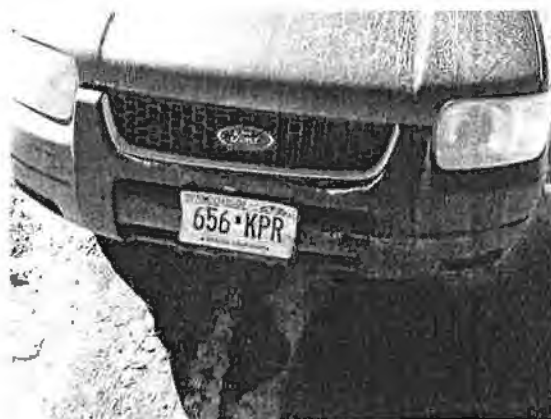
**Figure 2: Photographic reproduction of the incident 2003 Ford Escape**

The photographic reproduction of the incident 2003 Ford Escape depicted damage to the front license plate (Figure 2). There was dirt and mud covering a majority of the front structures, though there was no significant crush to the front bumper cover. The bumper cover was out of alignment with the hood.

Energy-based crush analyses have been shown to represent valid and accurate methods for determining the severity of automobile collisions.<sup>13,14,15,16,17</sup> Analyses of the photographs and geometric measurements of the incident Ford Escape revealed the damage due to the subject incident. An energy crush analysis<sup>18</sup> indicates that a single 10 mile per hour flat barrier impact to the front of an exemplar 2003 Ford Escape would result in significant and visibly noticeable crush across the

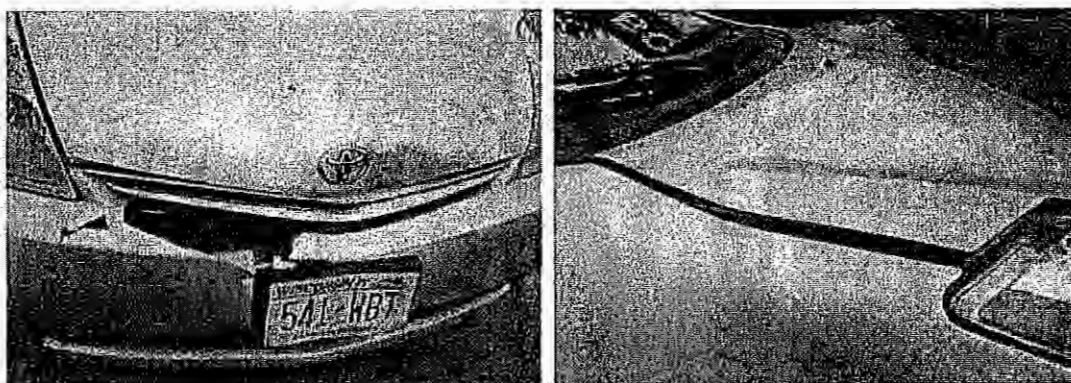
Figure 2: Reproductions of photographs of the incident 2009 Toyota Prius

The Insurance Institute for Highway Safety (IIHS) performs low-speed tests on vehicles to assess the performance of the vehicles' bumpers and the damage incurred. The damage to the incident Toyota Prius, defined by the photographic reproductions, and confirmed by the repair estimate, was used to perform a damage threshold speed change analysis.<sup>13</sup> The IIHS tested an exemplar Toyota Prius in a 6.2 mile-per-hour rear impact into a flat barrier.<sup>14</sup> The test Toyota Prius sustained damage to the front bumper cover, front bumper reinforcement, front bumper absorber, left/right headlamp mounting bracket, hood panel, hood panel emblem, hood panel latch, and hood lock vertical support. The damage is shown in Figure 3. The primary damage to the subject incident Toyota Prius was to the front bumper cover, front bumper reinforcement, left/right lower front bumper grille, lower front bumper grille, front bumper cover lower molding, front license plate bracket, left halogen headlamp assembly, left radiator side panel, hood panel, hood panel emblem, left/right hood panel hinge, and left/right fender nameplate. Thus, because the test Toyota Prius in the IIHS frontal impact test sustained similar damage, the severity and energy transfer of the IIHS impact is similar compared to the severity of the subject incident and places the Toyota Prius speed at the test speed of 5 miles-per-hour. Using conservation of momentum with a coefficient of restitution of 0.3, the subject Lincoln MKS experienced a Delta-V (the Delta-V is the change in velocity of the vehicle from its pre-impact, initial velocity, to its post-impact velocity) of 8.6 miles-per-hour or less.<sup>15,16</sup>

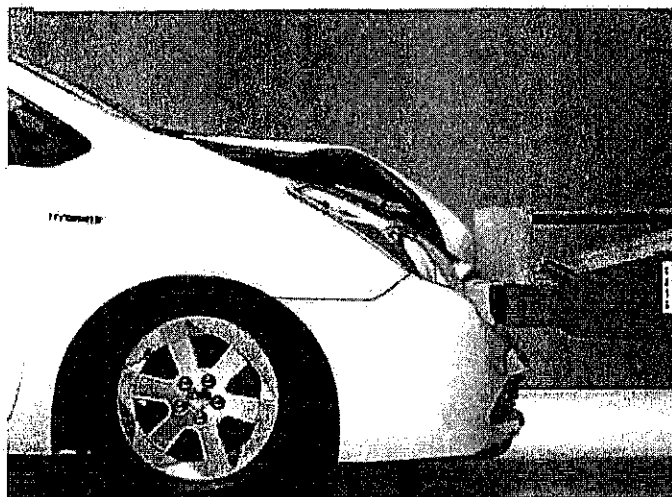
Figure 3: Reproduction of photograph of test Toyota Prius

Using an acceleration pulse with the shape of a haversine and an impact duration of 150 milliseconds (ms), the average acceleration associated with an 8.6 mile-per-hour Delta-V is 2.6g.<sup>17,18,19,20</sup> By the laws of physics, the average acceleration experienced by the subject Lincoln MKS in which Mr. Kamholz was seated was significantly less than 2.6g.

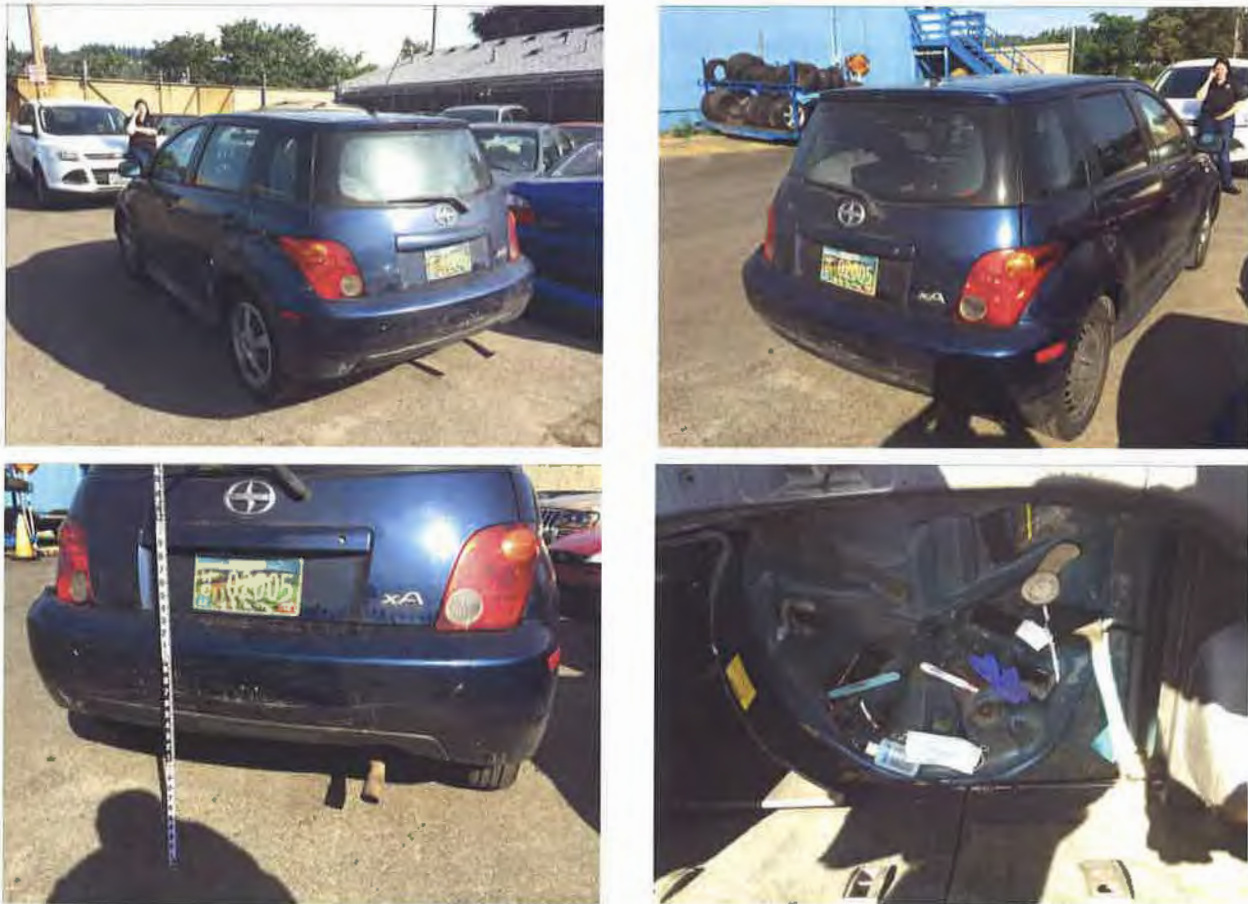
**Figure 1: Reproductions of photographs of the subject 2005 Scion xA**

displaced relative to the left quarter panel (Figure 1). The floor pan and reinforcement bar were also damaged.

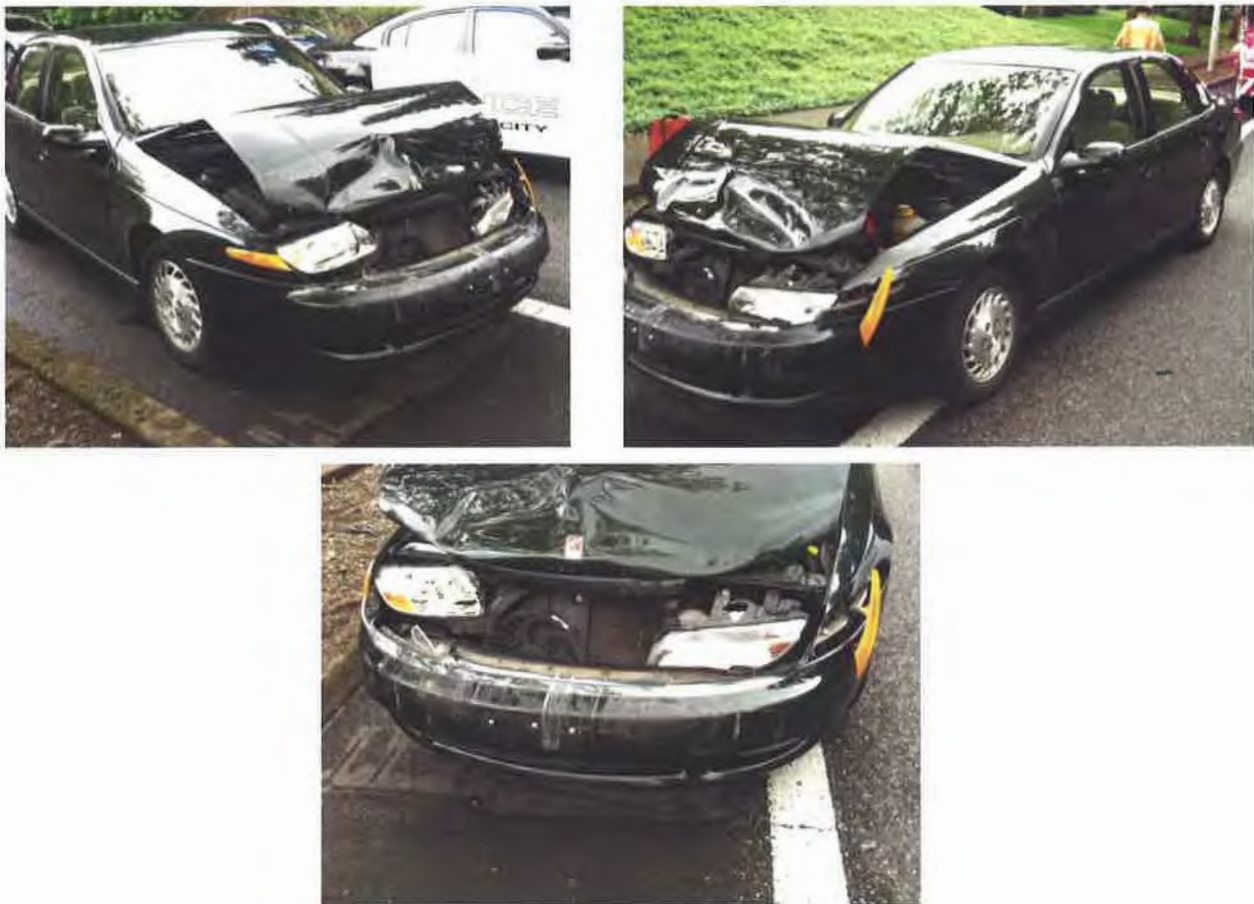
**Figure 2: Reproductions of photographs of the 2001 Saturn L200**

The photographs of the incident Saturn L200 depicted scrapes to the top of the front bumper cover, and crush to the grille (Figure 2). The headlamps were displaced, and the hood was crushed rearward. Given the amount of crush above the front bumper cover, compared with the low crush to the front bumper cover, the subject incident is consistent with an underride/override event. This means that the front bumper of the incident Saturn did not directly engage the rear bumper of the subject Scion. Rather, the Saturn's front bumper was below the Scion's rear bumper, which causes substantially more residual crush to the front components of the Saturn due to air space and non-structural components, compared to direct bumper contact at a similar speed. Peer-reviewed and generally-accepted methodologies for conducting residual crush measurements involve averaging the resulting deformation and revising the stiffness coefficients to determine the critical residual crush when an underride/override condition is present.<sup>13,14</sup>

Newton's Third Law of Motion states that for every action there is an equal and opposite reaction. This law dictates that a scientific analysis of the loads sustained by the incident Saturn L200 can be used to resolve the loads sustained by the subject Scion xA. That is, the loads sustained by the incident Saturn are equal and opposite to those of the subject Scion.
